**AERIAL**

**152 CHARLES STREET**

BALANCE BA ARCHITECTS

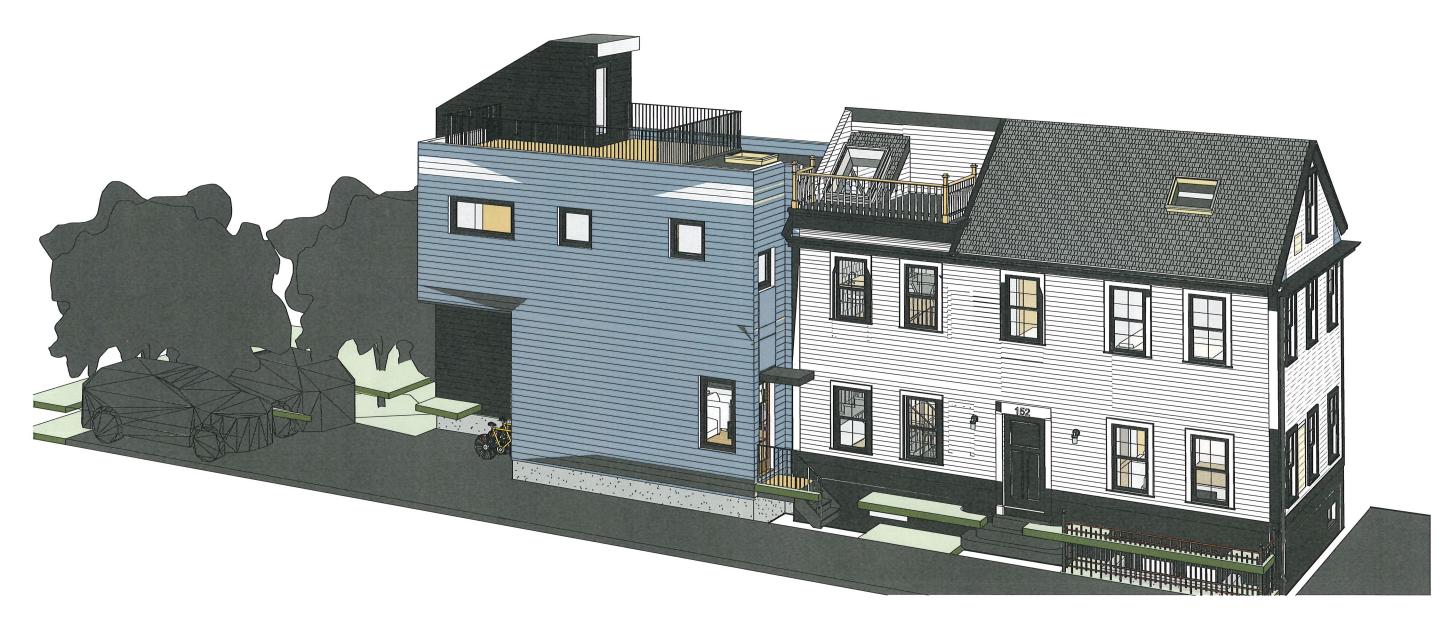
"LANDED FROM OUTER SPACE"

"HORRIBLE"

"ROOF DECKS AREN'T ACTUALLY USED"

"SNORKEL TO THE ROOF"

"CRAMPED ENTRANCE"

"NO CONTINUITY OR RELATIONSHIP BETWEEN BUILDINGS"

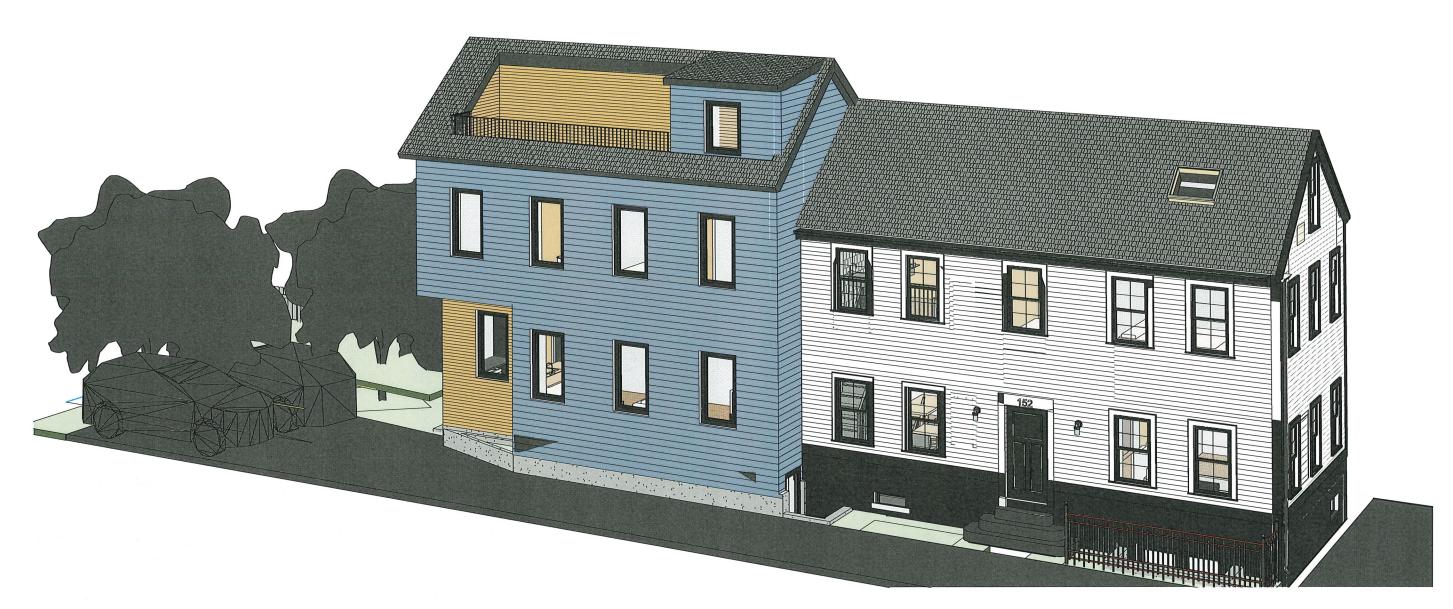
- REMOVED ROOF DECK FROM EXISTING BUILDING
- SIMILAR FENESTRATION RHYTHM, DIFFERENT FENESTRATION TYPE
- SNORKEL IS A DORMER
- CARRIED ACROSS SIDE YARD ROOF LINES BETWEEN BUILDINGS
- REAR ROOF DECK ORIENT AWAY FROM 158 CHARLES MORE PRIVACY
- FENCE BETWEEN 152 & 158 CHARLES

- UNIT 2 ENTRANCE MOVED TO REAR
- UNIT 2 FOOT PRINT SIMPLIFIED (REMOVED JOGS)
- UNIT 1 DEDICATED OUTDOOR AREA
- MOVED STAIRS AWAY FROM WINDOWS

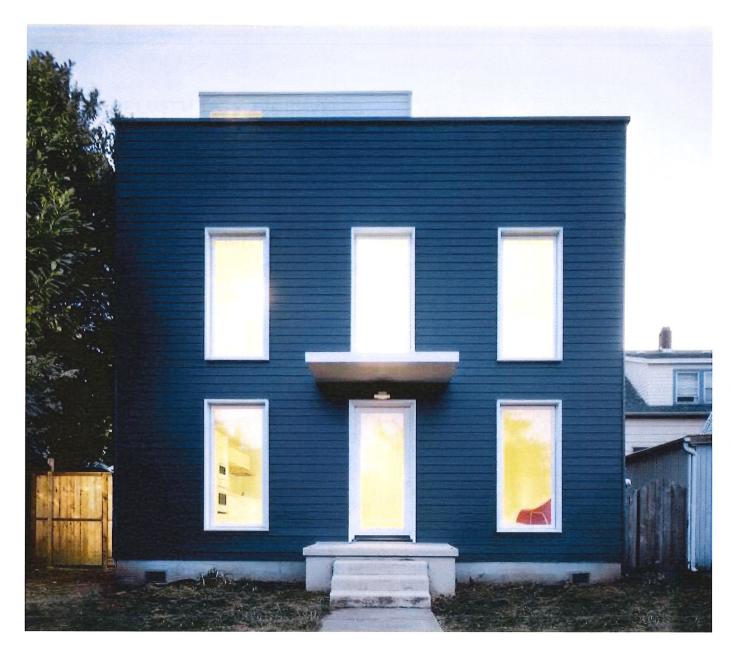
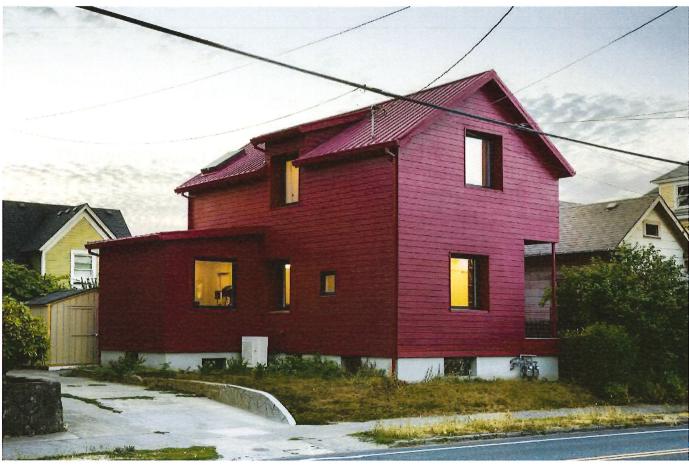
UNIT 2 PRECEDENT

- PUNCHED WINDOWS CASEMENT
- LIMITED TRIM/ORNAMENTATION
- SIMPLIFIED GEOMETRY
